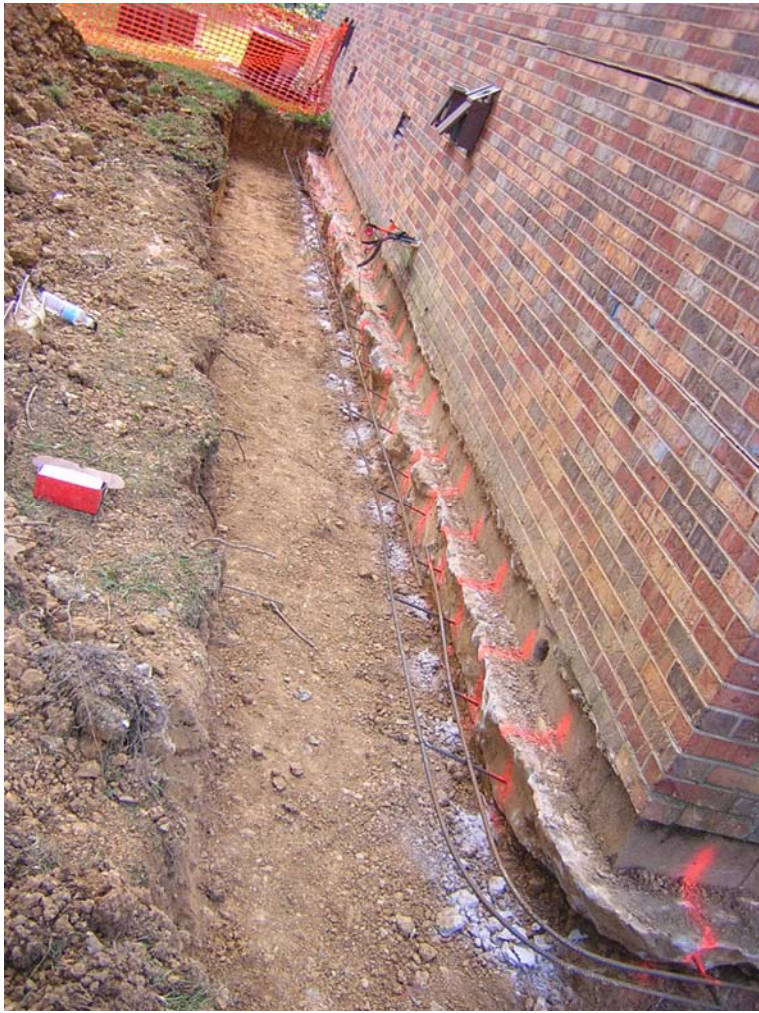
Foundation has been excavated and rebar added to the existing foundation

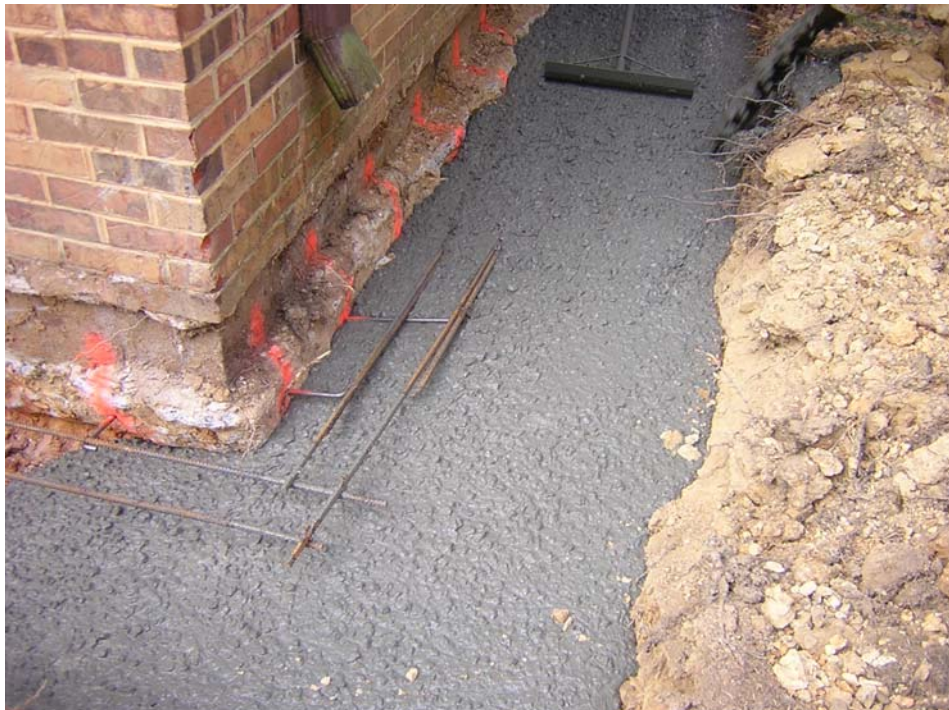
New concrete is poured adding width to the foundation.

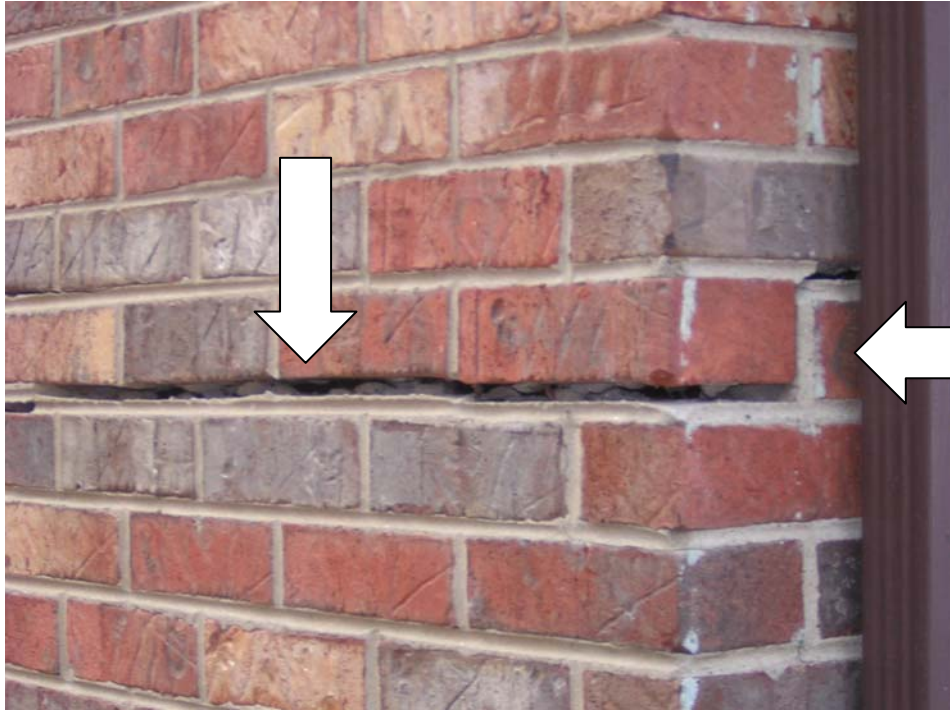
Crack in brick veneer before the foundation lifting process.

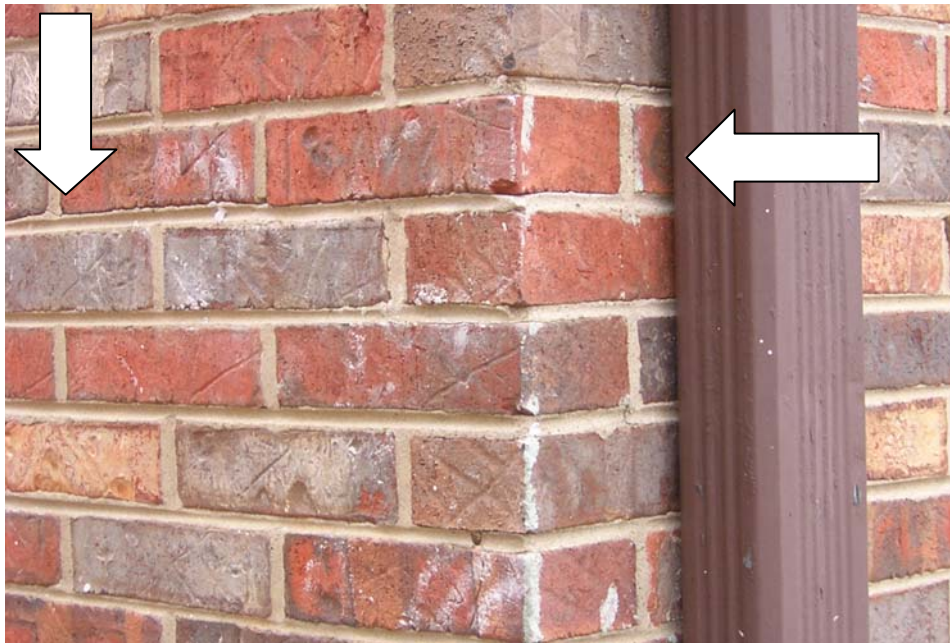
The crack in the brick veneer is now almost completely closed after the lifting process.
